RESULTS OF TURBOJET ENGINE OPERATION TESTS USING
A 50-50 MIXTURE OF JP-4 AND TRIBUTYL BORATE
AS THE FUEL

By Louis J. Schafer, Jr., and Francis S. Stepka

Lewis Flight Propulsion Laboratory
Cleveland, Ohio

NACA RM E52L17a

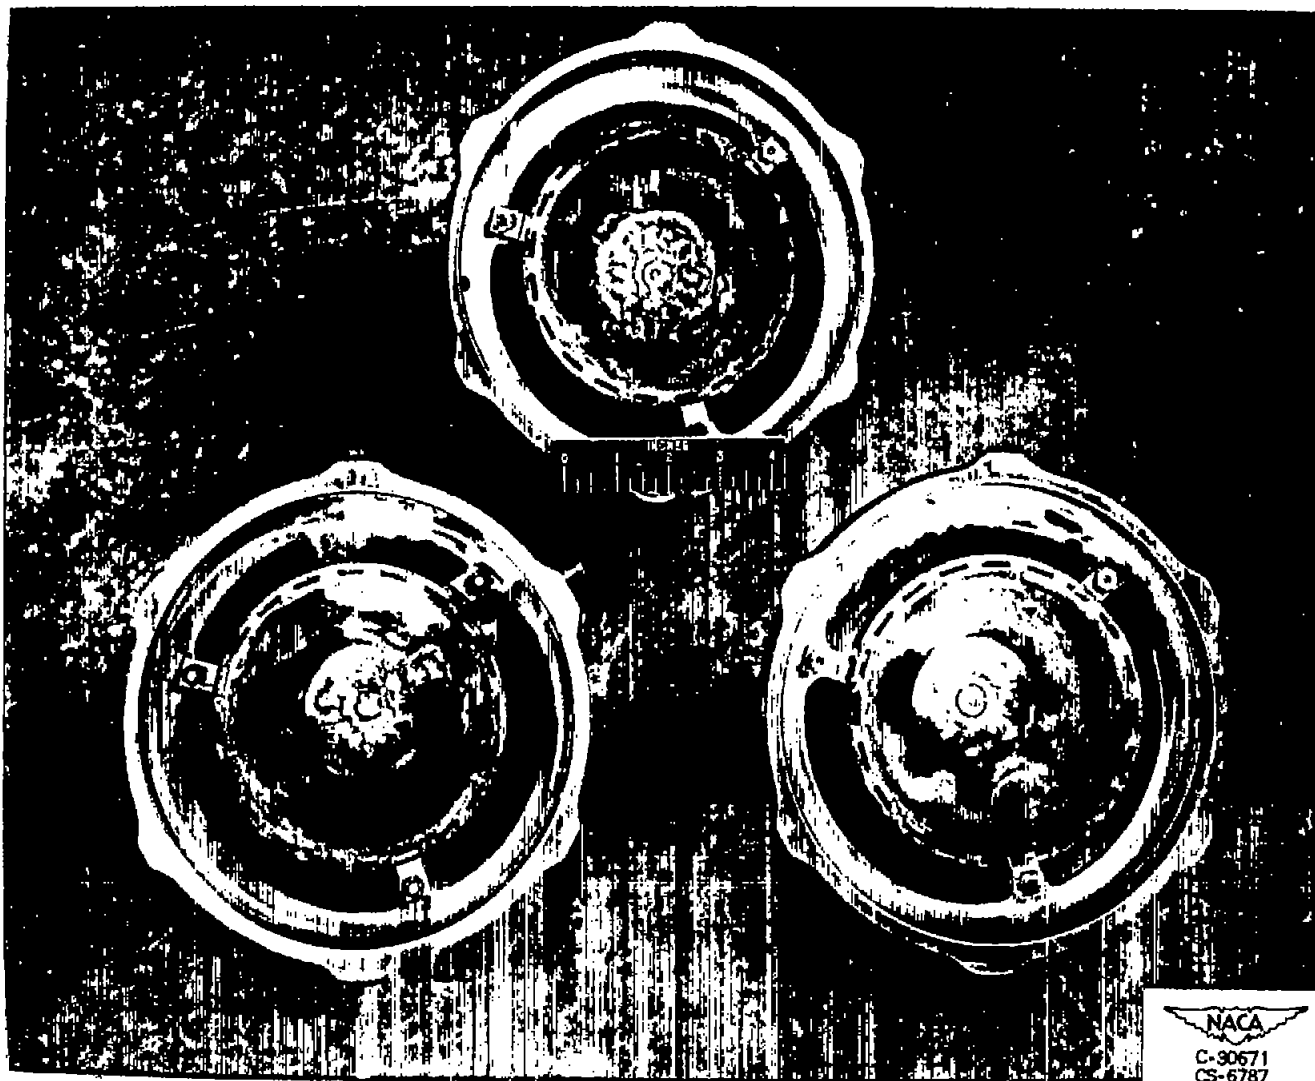
Three fuel nozzles assembled in their burner domes are shown in figure 1. The deposits in these parts were thicker than in any others. The deposits were heaviest on the fuel nozzles and on the air spinner disk which fits around the fuel nozzles. It is conceivable that the deposit on the fuel nozzles could build up to such a degree that it would alter the shape of the cone of the fuel spray and thus reduce the combustion efficiency. Besides having the boric oxide deposit on the outside, several of the fuel nozzles were completely plugged. This was probably a result of the fuel left in the nozzles hydrolyzing after the engine was shut down. This is a characteristic of the high-energy fuels also, and is a disadvantage that must be considered. The build-up of boric oxide on the air spinner disk was very heavy also. The vanes in the spinner were almost completely plugged. This condition did not seem to have any effect on the engine operation. The air adapter containing the spark plug is shown at the lower left corner of figure 1. Some evidence of the deposits was observed on the spark plug electrodes, but they did not close the gap. The spark plug still operated satisfactorily. The coating on the burner dome was not as thick as it was on the other parts shown in figure 1.

1. The greatest accumulation of boric oxide in the engine was found in the burner domes where the air spinners were almost completely plugged and the boric oxide deposits on the fuel nozzles was such as to possibly alter the shape of the fuel spray and decrease the combustion efficiency.

Figure 1. - Build-up of boric oxide deposits on fuel nozzles and burner dome.

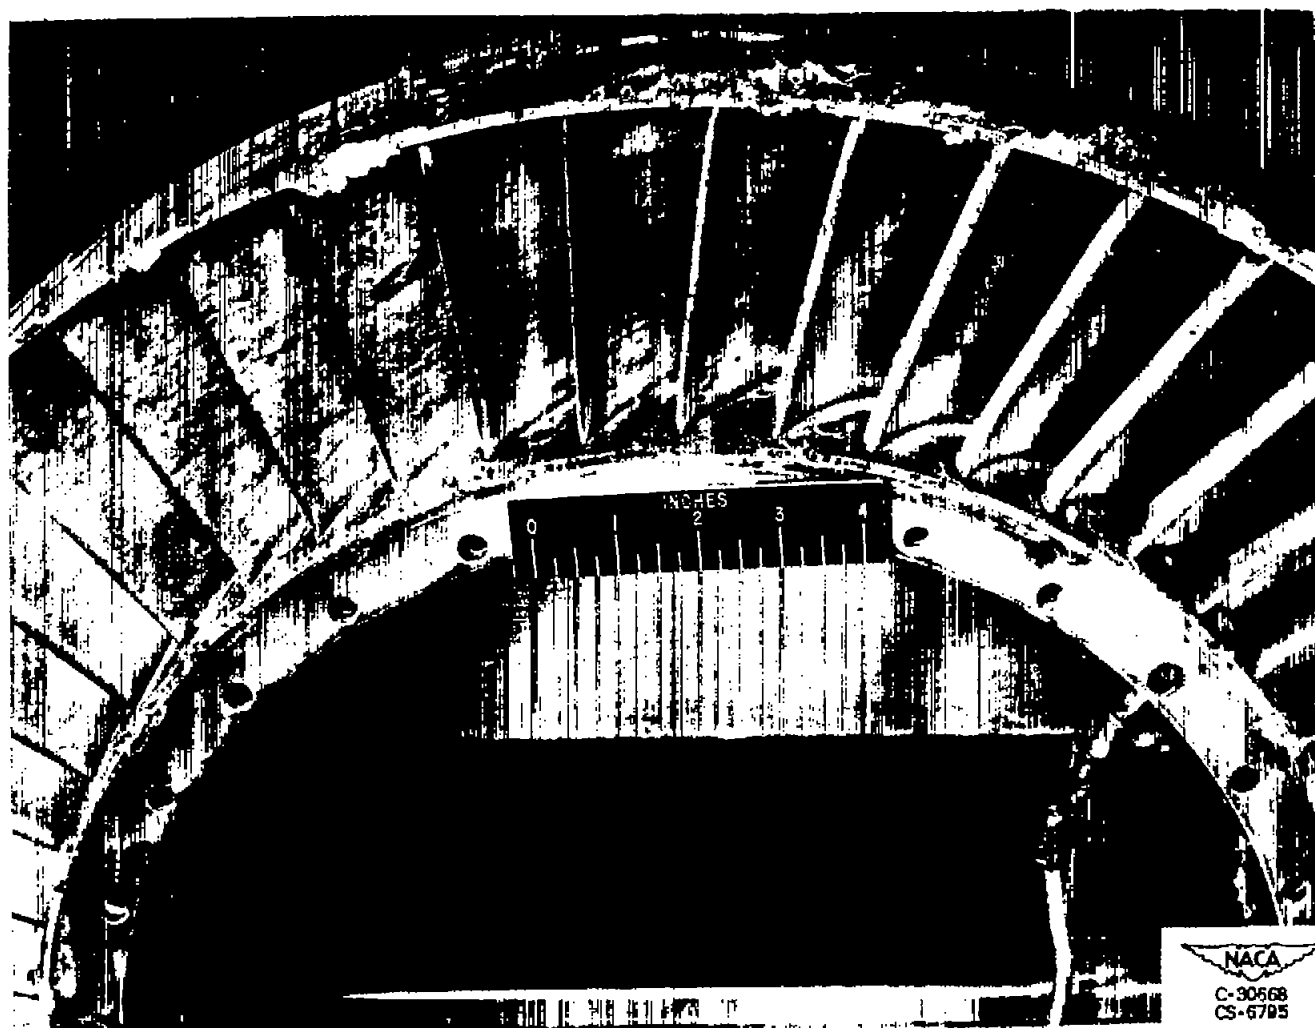
(a) Upstream side of diaphragm.

The deposit formations on the upstream and the downstream sides of the nozzle diaphragm are shown in figure 4. The deposits on this part are the molten type of deposit. The deposits on the nozzle blades were insignificant. Most of the deposit was found around the outside of the outer diaphragm ring where it would have no effect on the aerodynamic performance of the nozzles. There was also a coating of the deposit on the gas seal rings between the nozzle diaphragm and the turbine rotor.

Figure 4. - Build-up of deposits on nozzle diaphragm.

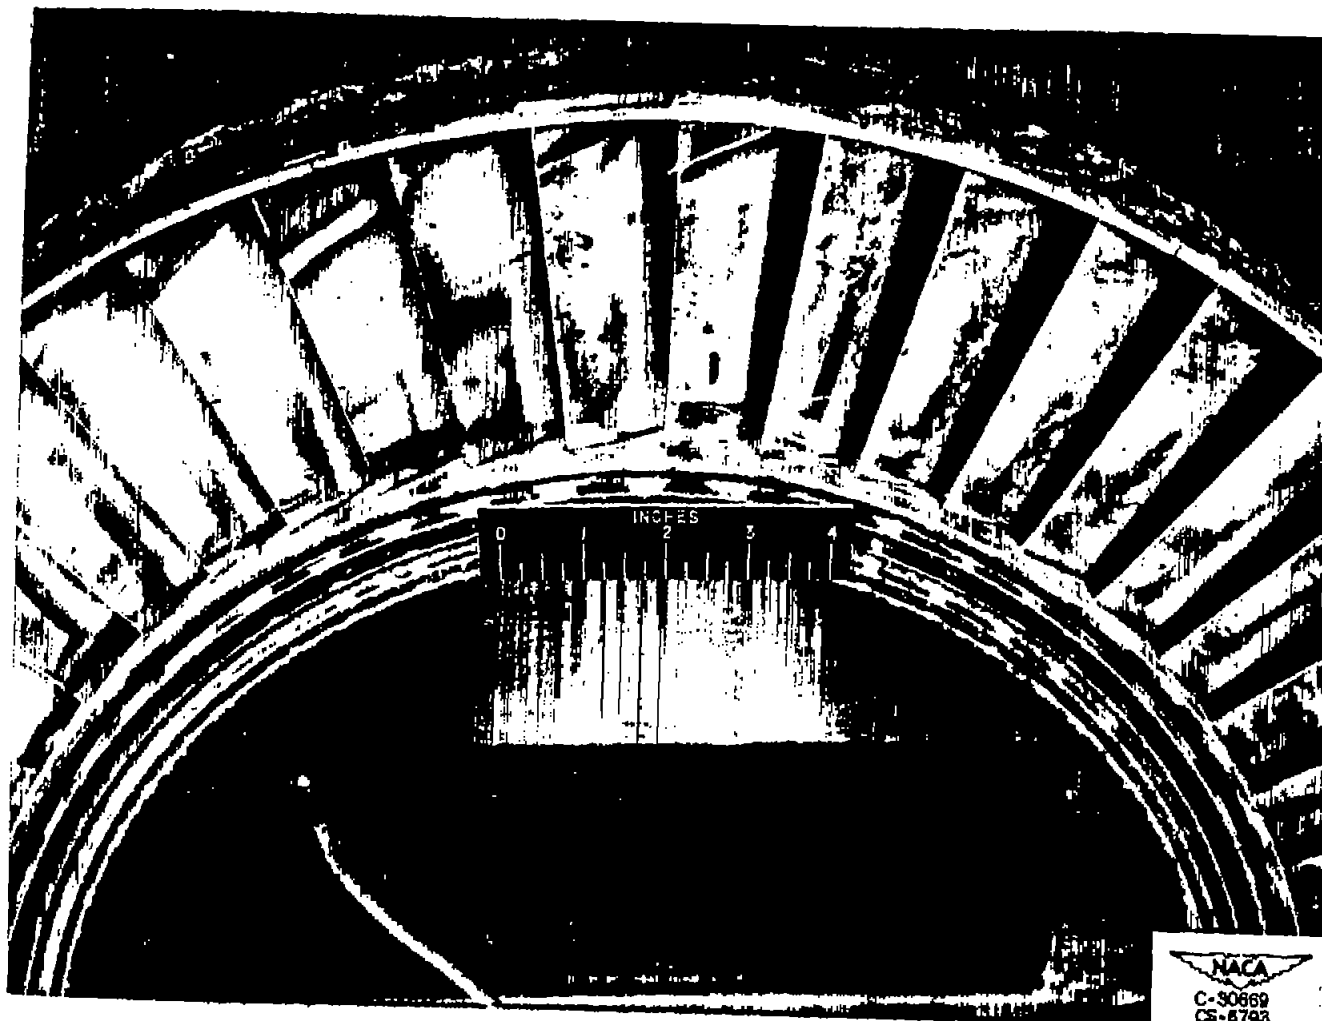
(b) Downstream side of diaphragm.

Figure 4. - Concluded. Build-up of deposits on nozzle diaphragm.

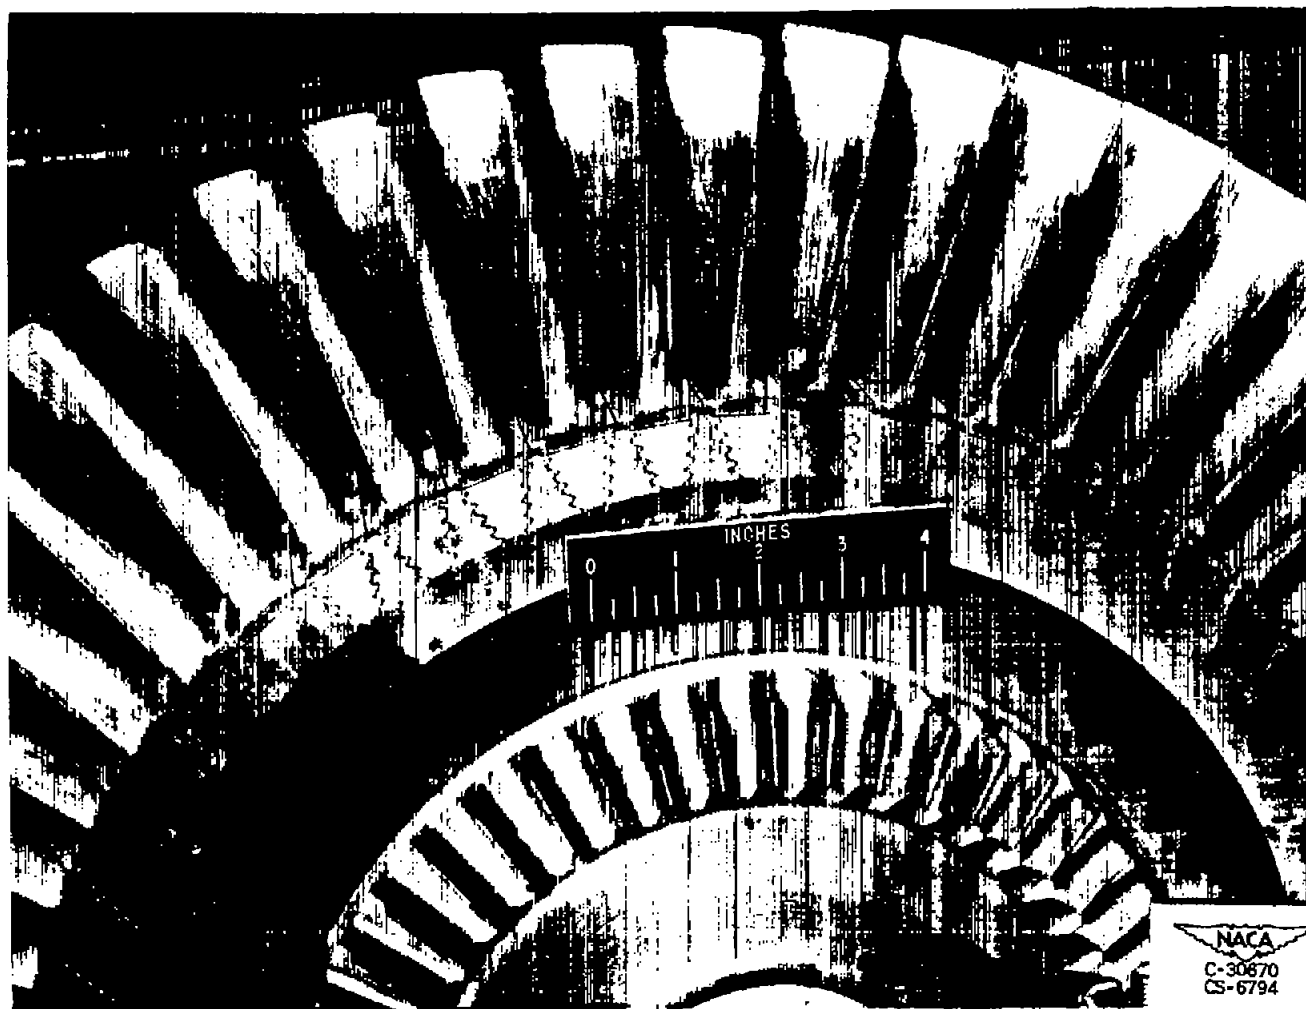
(a) Upstream side of rotor.

Photographs of the upstream and the downstream side of the turbine rotor are shown in figure 5. The deposits on this part were very thin.

The boric oxide that formed on the blades evidently was thrown off the blade tips. This flow of the deposits along the blade span is borne out by the nearly radial flow lines that can be seen on the blades in figure 5(a). The pressure surface of the rotor blades was covered with the deposits more completely than the suction surface. Only the tip half of the suction surface (fig. 5(b)) showed evidence of any coating. The turbine rotor disk had no coating of boric oxide on the upstream side but the downstream side showed a very thin, uniform coating.

Figure 5. - Build-up of deposits on turbine rotor.

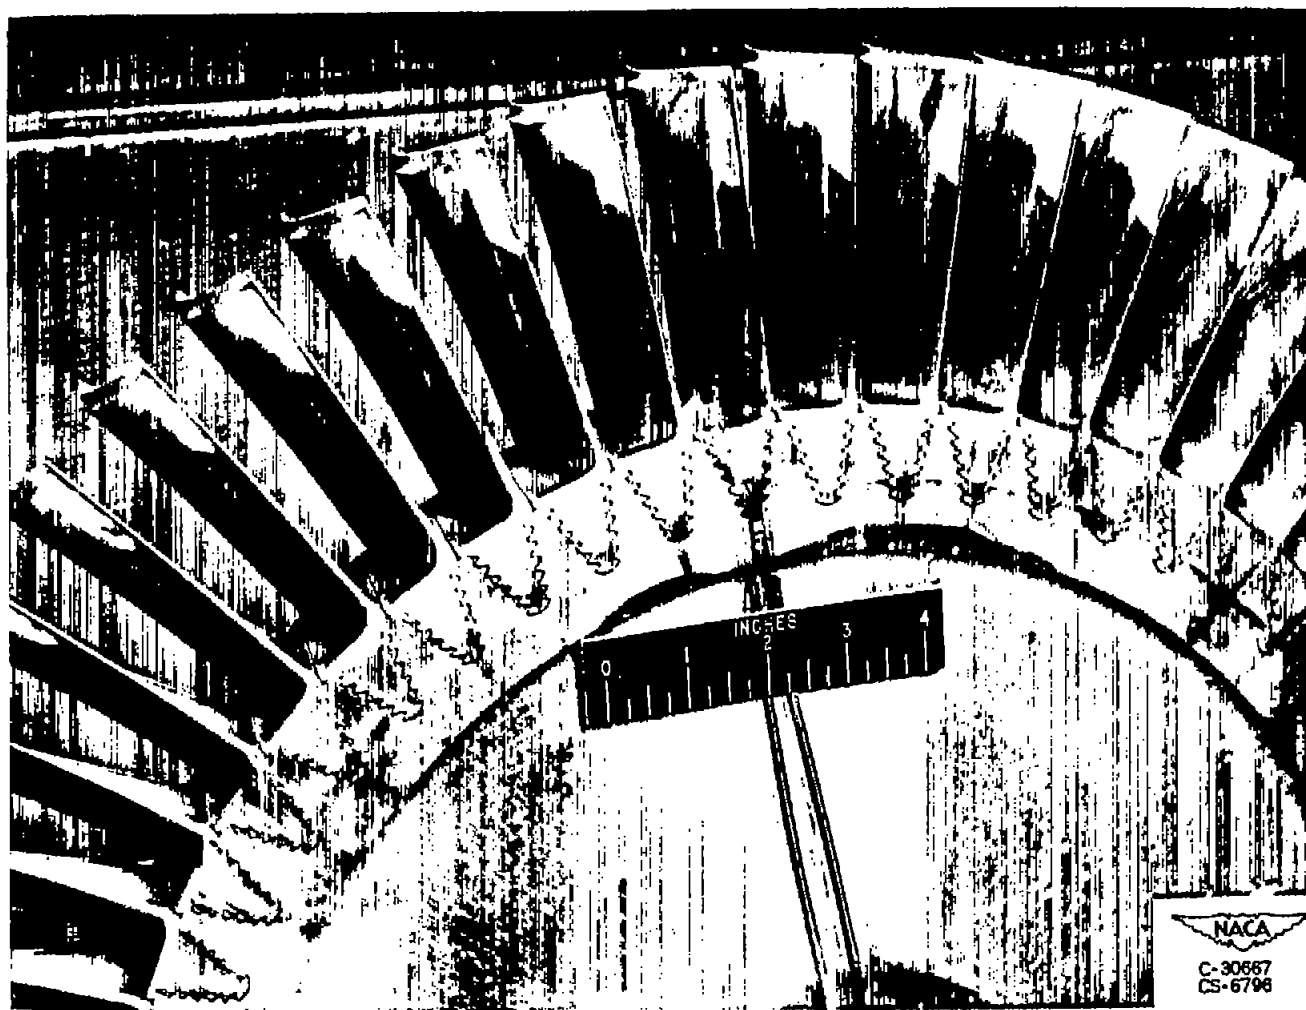
(b) Downstream side of rotor.

Figure 5. - Concluded. Build-up of deposits on turbine rotor.

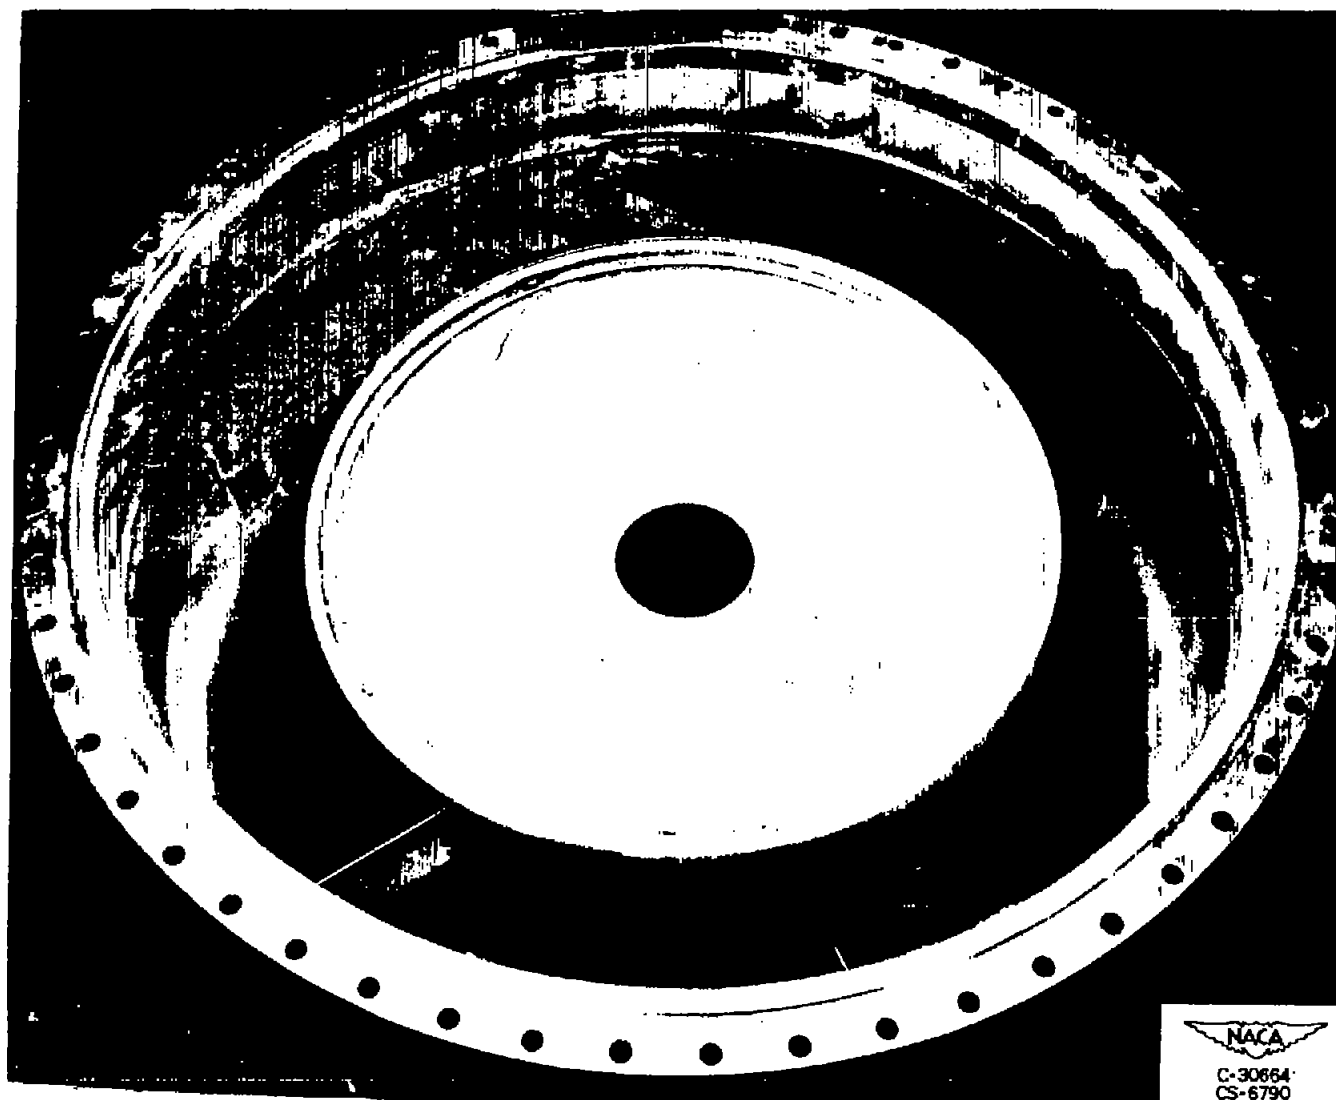
The tail cone (fig. 6) had a thin coating of boric oxide that had been thrown from the tips of the turbine rotor blades and flowed along the inside surface of the outer exhaust cone. Besides these streams of boric oxide there was a uniform thin coating over the entire inner surface of the tail cone.

Figure 6. - Build-up of deposits in exhaust tail cone.

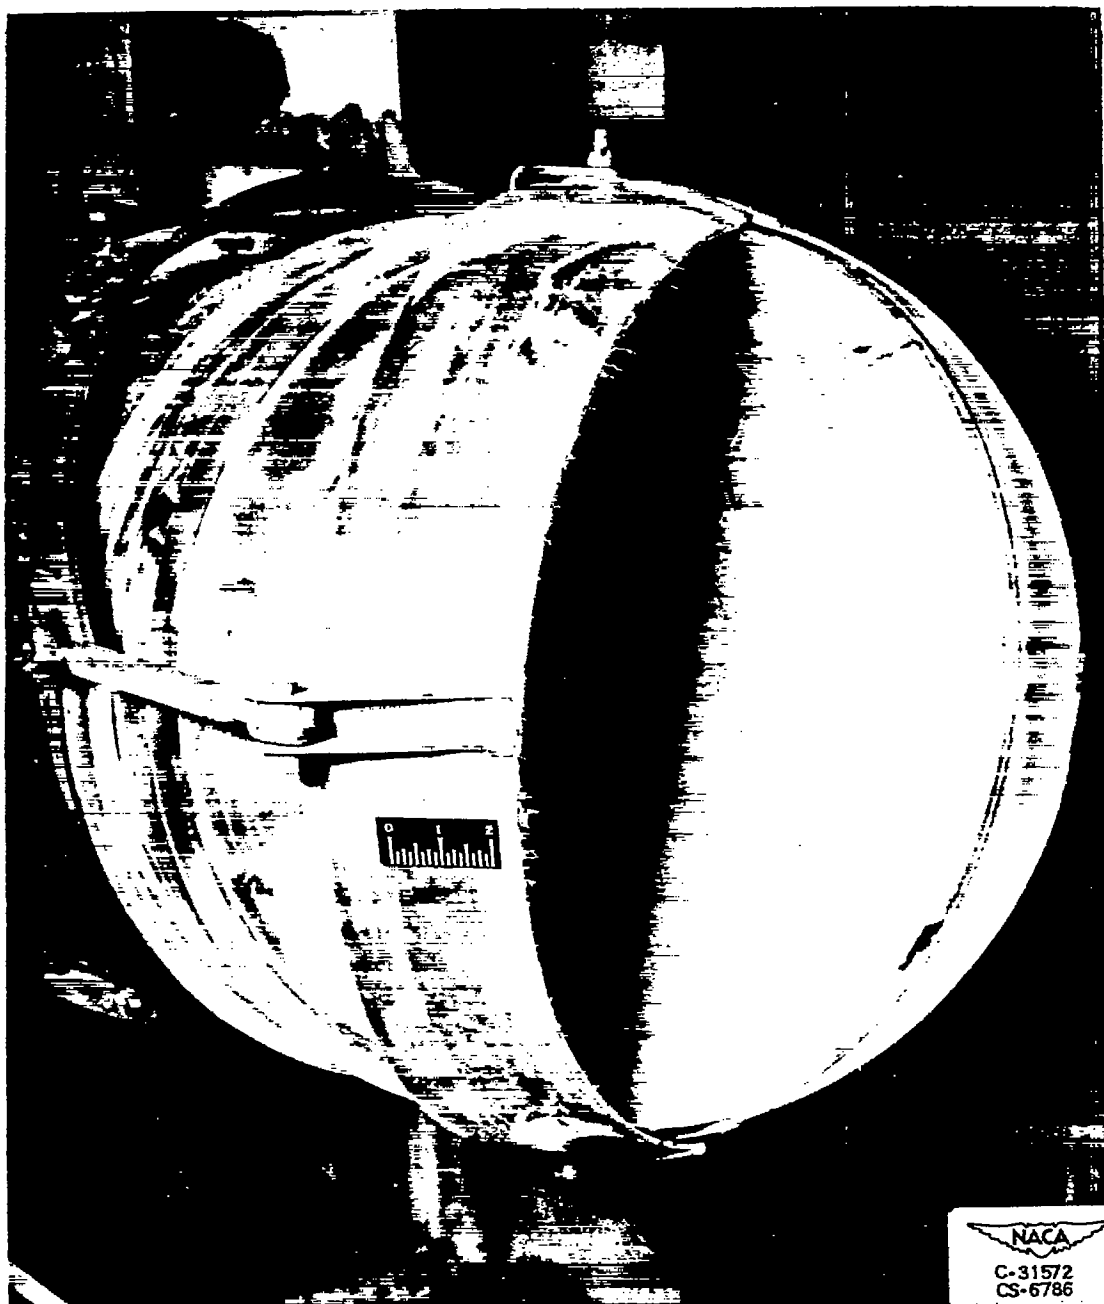
There was a thin coating over the inside surface of the tail pipe and a light fringe of the deposit at the exit of the tail pipe nozzle as shown in figure 7. The exhaust-gas thermocouples that were located in the tail pipe had a thick coating on their downstream side, but the coating did not affect the temperature measurements that were made with them.

Figure 7. - Build-up of deposits on exhaust tail pipe nozzle.
